# EPOXY<sup>®</sup> WORKS

BUILDING, RESTORATION,  
& REPAIR WITH EPOXY

ISSUE  
NO. 60

SPRING  
2025

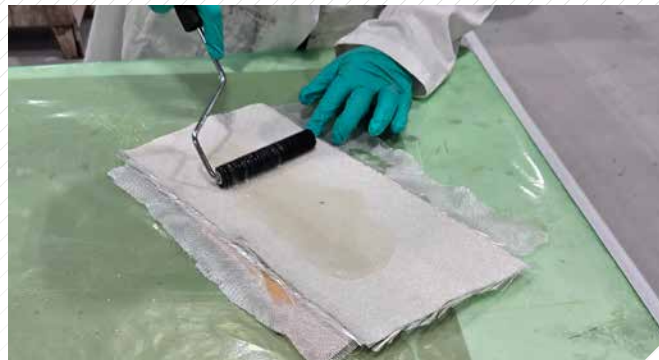
Rollers can be especially helpful at compacting multiple layers of reinforcing material, making for a stronger laminate.

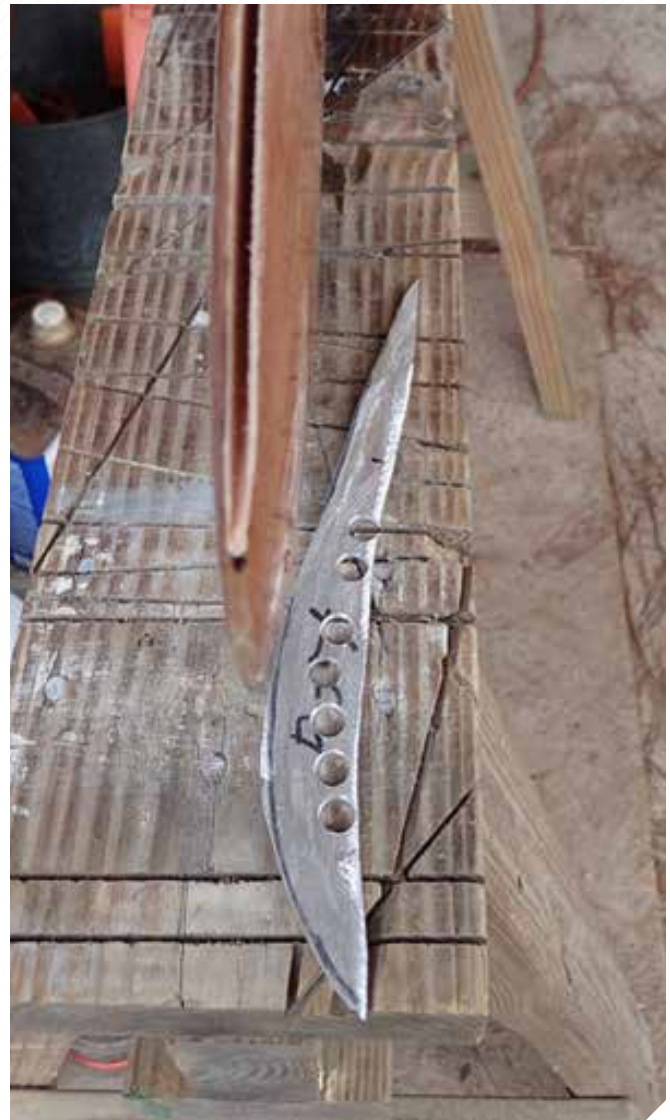
**BOTTOM RIGHT:**

The aluminum piece to be glued into the slot in the "toe" of the leeboard, which hits the sea bottom first. After twenty years of oyster-chewed leeboards, regardless of glass, Kevlar, and/or carbon powder experiments, the aluminum inserts are the fix.

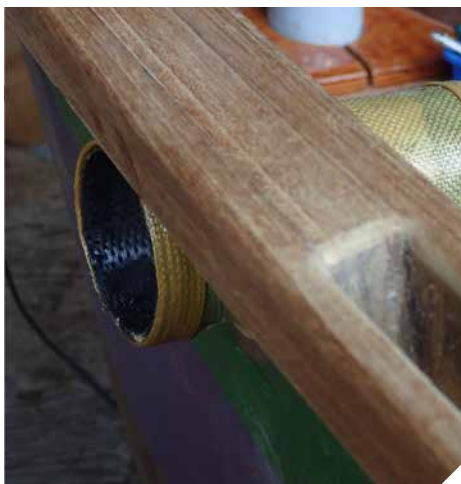
**TOP:** Kevlar in the outhaul system. The outhaul car is a Kevlar molding with a block for a double-purchase. The boom's end fitting is Kevlar, eliminating a sheave and almost all metal, while reducing length and mass.

**BOTTOM:** Leeboard cone, molded off of ones originally built by Jan Gougeon.

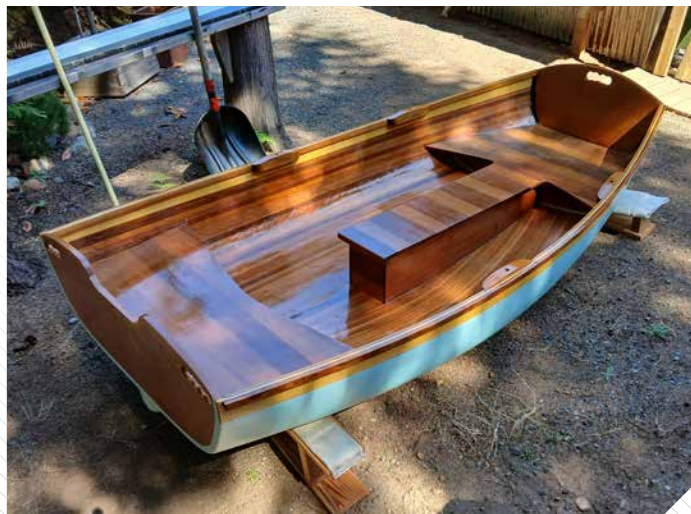
# WOOD DINGHY BY ROBERT HALE

This design is Nick Schade's "Coot" plan. It was built by Robert Hale using clear old growth red cedar  $\frac{1}{4}$ " x  $\frac{3}{4}$ ". He tried to orient as many strips fore and aft as possible, but the last eight strips went in straight, and he tapered the ends. These were edge glued and covered in 6 oz. fiberglass inside and out using WEST SYSTEM® Epoxy. The transom is cherry.

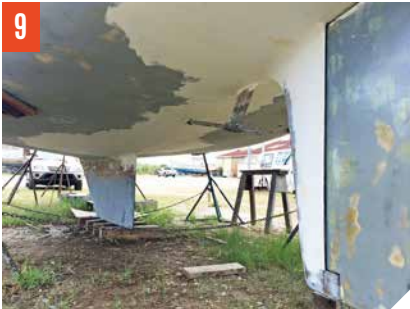
The survey revealed that water had seeped into the Kauri diagonal layers in three places: at the sheer near the stem, under the toe rail starboard aft, and most critically, in about 14 ft<sup>2</sup> of the hull bottom on centerline between the keel and the rudder **FIG. 9**. This last was due to a collision *Corroboree* had had some years before with a submerged container in Lake Erie and subsequent poor repair. We hired shipwright John Lubbehusen to craft repairs for all three spots by replacing the soaked Kauri layers with new African Mahogany layers set in WEST SYSTEM 105 Epoxy Resin® and hardener **FIG. 10**.

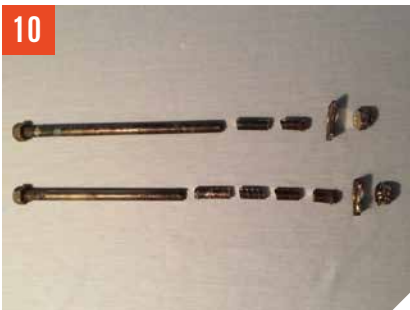
Shortly before launch we discovered that two of the nine bronze keel bolts were broken **FIG. 10**. It was another consequence of the collision and poor repair. A marine surveyor located the lower ends of the keel bolts in the lead keel casting by thermographic imaging and verified their positions with the construction plans. We replaced the broken bolts with new ones.

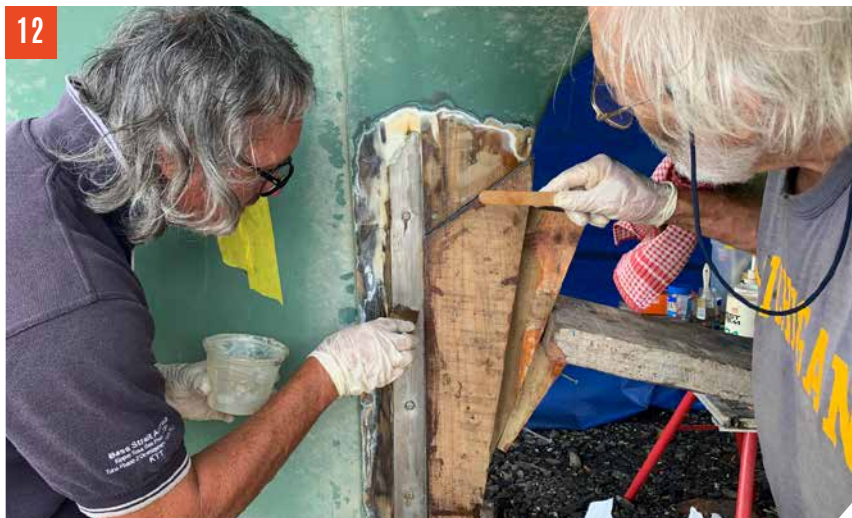
Once on the town's only slipway, we dropped the rudder and discovered the front lower end of the rudder skeg was badly cracked. Fortunately, through the friendliness of locals eager to help two stranded Americans, we were able to locate a huge stack of 2" thick Teak flitches that had been harvested and air-dried naturally at a local farm four years previously. We bought a 10' x 18" flitch to fashion a new skeg. We cut off the cracked bits and then rough-cut a new Teak plug which we glued into place and anchored with four 8 mm dia. stainless steel threaded rods, pocketing them with WEST SYSTEM Six10® Thickened Epoxy Adhesive **FIG. 12.**

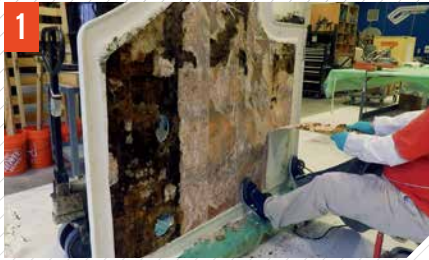
I was done. Next was removing the inner skin. I was hoping the core was rotted enough that I could remove it in one piece and reinstall it after replacing the core, but no luck. Cutting the skin into 1' strips, I could peel and chisel it off. Exposing the rotted core, I could see there was in a large grid pattern and the center of the grid was damp, but not completely rotted. This reflected what I saw with the thermal camera **FIG. 1**.

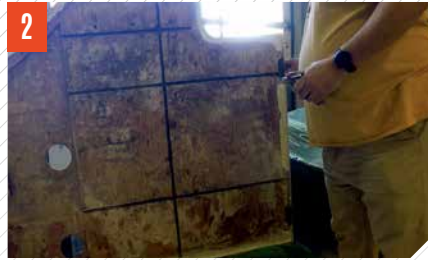
I drilled oversize holes for the hinge screws and used Six10<sup>®</sup> Thickened Epoxy Adhesive to fill them. Six10 is great at gap-filling with its thick and creamy consistency. It also worked perfectly for bonding the Coosa board backing block where the water was originally entered the core **FIG. 2**.

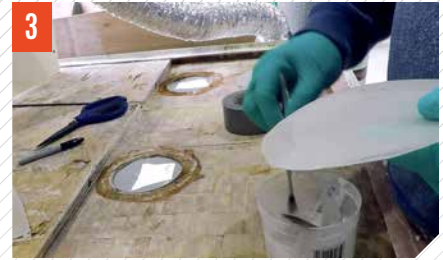
The top skin needed to be airtight for the vacuum to work properly. Using two layers of our 737 Biaxial Fabric, wet out with 105 Epoxy Resin<sup>®</sup> and 205 Fast Hardener<sup>®</sup>, I made fiberglass laminates to use as cover plates for the table support openings. G/5<sup>®</sup> Five-Minute Adhesive worked great to bond them inside the outer skin quickly **FIG. 3**.

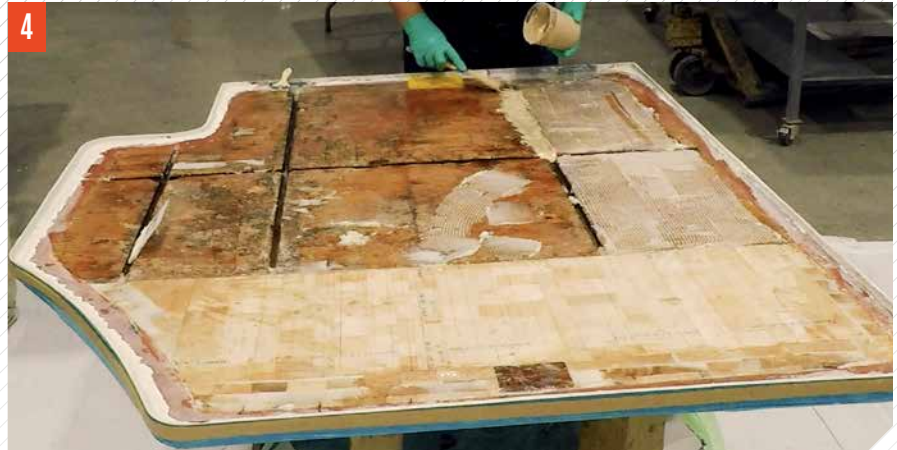
The final layer to seal the envelope was the 882 Vacuum Bag Film **FIG. 5**. Even though this was a flat panel with minimal contour, I still cut my bag approximately 1.5 times the size of the overall hatch. The bag had to be large enough to fit tightly into the contours. The core only steps up about  $\frac{3}{4}$ ", but it is better to have too much film than not enough. I peeled the paper backing off my 883 Vacuum Bag Sealant that I had adhered around the perimeter of the hatch and applied extra to seal any pleats or folds in the bag film.

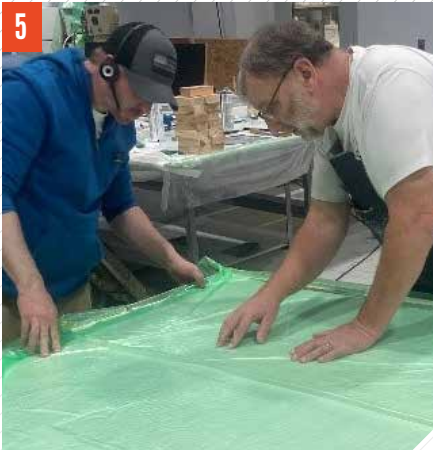
**LEFT:**

The bottom of the finished engine hatch—sealed and gelcoated.

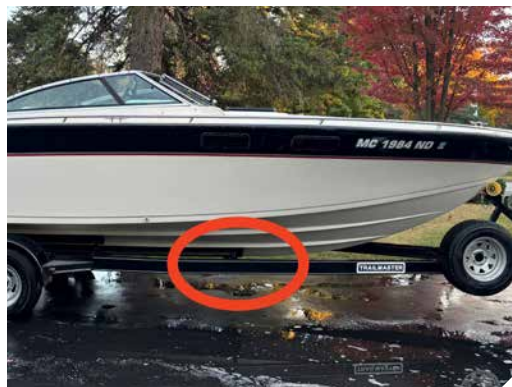
## RIGHT:

The gelcoat cracks were isolated to the forward end of the bunk (highlighted).

- The cracks were only in the forward area of the bunk and concentrated around the end of the bunk.
- The bottom would have maximum deflection from wave pounding between the keel and the inboard stringer, not at the keel.
- The cracks were in an area of high deadrise which reduces slamming loads.
- The forward edge of the bunk is located midway between the axles and the trailer tongue where the trailer has the greatest deflection.
- This area of the bunk has significant wear from road vibration, loading, and unloading.
- They have been forming over the course of several years.
- The cracks do not continue forward of the frame that creates the aft end of the vee-berth.
- When tapping this area, it did not have the sharp ring as with other areas, instead it produced a dull thud indicating less stiffness than the surrounding area.

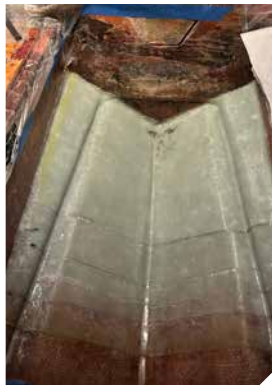
### LEFT:

The forward six layers of fiberglass were all applied in one session. Each layer stepped back so the butt joints would be staggered.

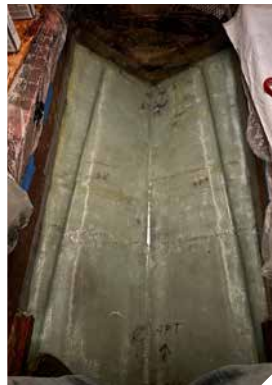
### MIDDLE:

Once cured, and the surface prepared, the aft layers could be applied.

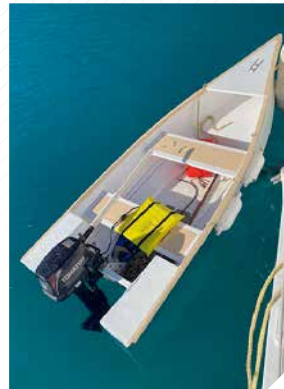
Over the last off-season, Robert Petersen converted the bare aluminum hull of his RIB dinghy into a hybrid plywood/aluminum hull using ¼" ply and WEST SYSTEM® products. Robert looks forward to using her as a dinghy for his 1971 Jim Brown 37' Searunner as he sails the United States Virgin Islands in St. Thomas.

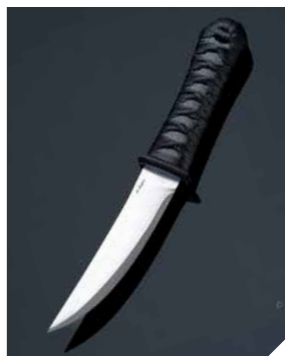
### KNIFE BY MATTHEW GREGORY

This neo-Japanese style fighting knife, with composite construction handle, was made by Matthew Gregory. The 6" long blade is made of a Crucible Steel laminate of CPM-154 stainless cladding over a core of high wear resistance tool steel Crucible CPM-10V. The handle consists of a G10 and carbon fiber frame, with an aerospace foam material called Rohacell (to add dimension with

almost no weight). It's sleeved in carbon fiber, and bonded with WEST SYSTEM® 105/207 under vacuum. The seppa and menuki are both titanium, and the guard is carbon fiber. WEST SYSTEM 105/205 was used for the final assembly. Instagram @mggregoryknives.

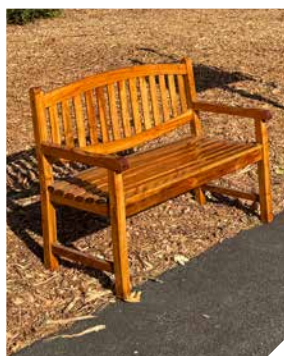
### CONDO BENCH BY PAUL HAYES

Reader Paul Hayes recently donated this bench to his condo association so residents would have a nice location near the mailboxes to sit and read their mail. This teak bench had spent some time outside and therefore had become discolored. He sanded the bench on his dry, enclosed porch and removed any sanding dust. Having some limited exposure to WEST SYSTEM® Epoxy

from the sailing world, he decided to use that to seal the wood. He applied four applications, being careful not to create "gas bubbles" by letting the porch get too hot or humid. He sanded between each coat. Over top he applied 4-5 coats of a marine grade varnish, wet sanding as high as 2,500-grit.
